Corrosion Control of Central Vehicle Wash Facility Pump Components Using Alternative Alloy Coatings

Final Report on Project F09-AR14

Michael K. McInerney and Robert B. Mason, Jr.

July 2016

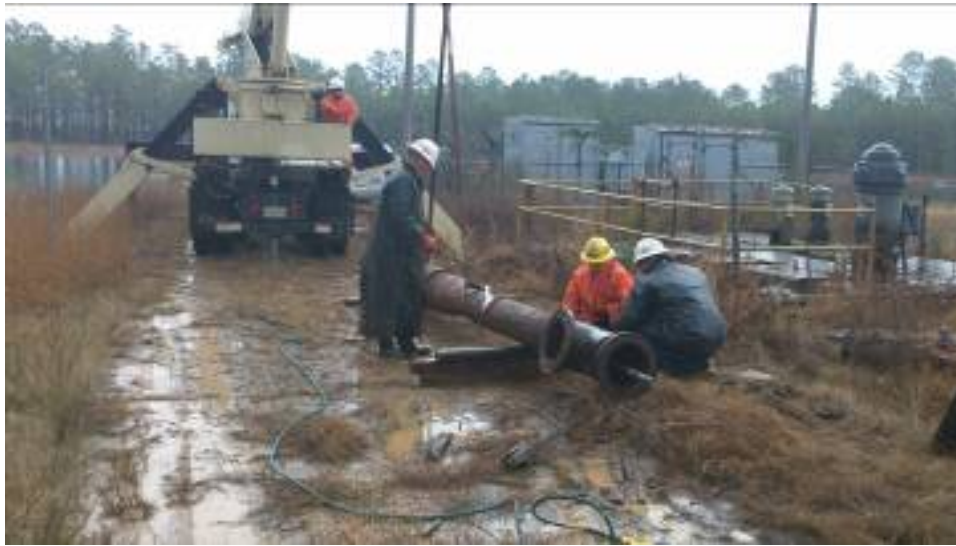
Figure 7. Old (inoperable) Unit 2 pump disassembly.

The installation took place at the Fort Polk CVWF North Station in January 2011. Before installing the new pumps, Fort Polk “outside” electricians (electricians who work with outdoor high voltage equipment) were called to disconnect the primary power to the pump station. The north-side pump (hereinafter referred to as Unit 2) was disconnected and removed first. The old Unit 2 pump was placed on the ground, and the existing header was removed to be reused with the new pump. The disassembly of the old Unit 2 pump is shown in Figure 7.

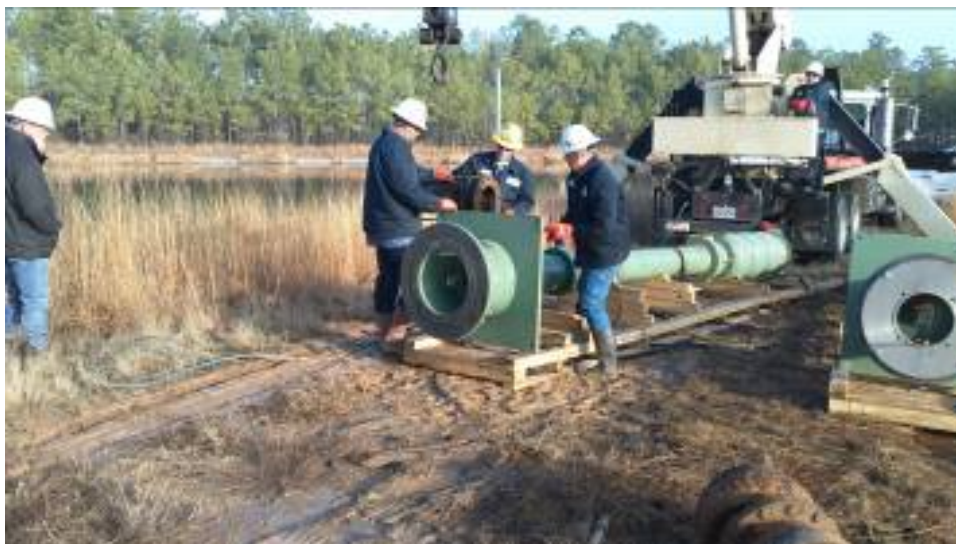
Figure 8. New Unit 2 pump header installation.

The new Unit 2 pump was fitted with the header pipe that was removed from the old pump, but it did not fit properly and could not be used. A welder made a new header pipe that fit properly. The installation of the new header pipe is shown in Figure 8.

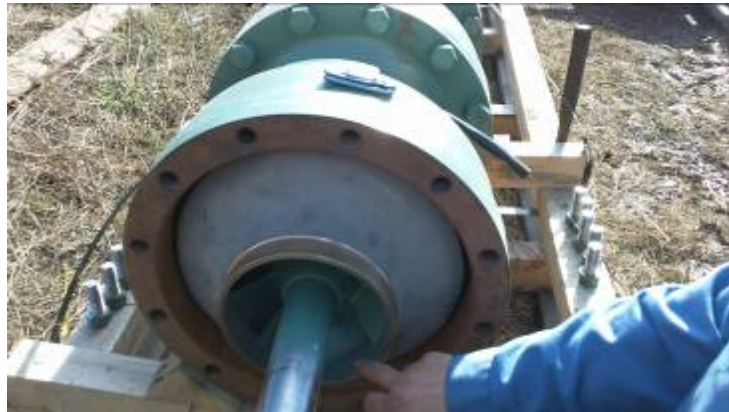
Figure 9. New Unit 1 first-stage impeller coating configuration.

The bottom cap of the new south-side pump (hereinafter referred to as Unit 1) was removed to verify what type of coating was on the impeller prior to installation, as seen in Figure 9.

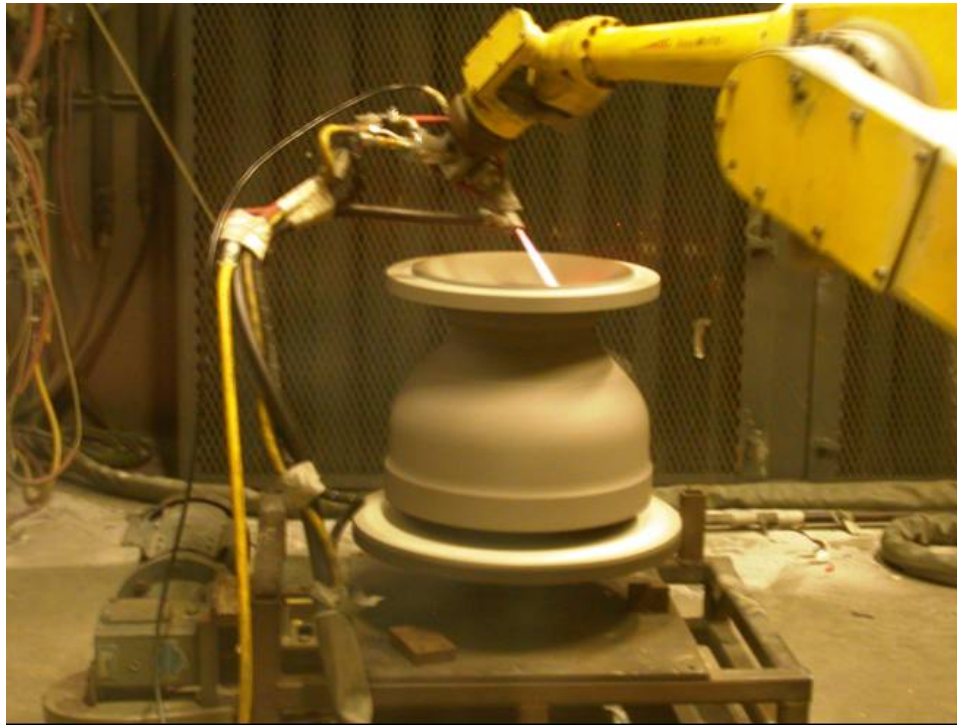
Figure 19. Stellite 6 coating being thermally sprayed on underside of pump bowl.

The new pump components were sent to two different facilities for coating. At one facility Stellite 6 coatings were applied to the pump components. Upon arriving at the site, the pump components were found to have a small amount of superficial surface corrosion. Prior to coating, the parts were grit blasted to provide a clean surface to promote coating adhesion. The parts were then coated using the HVOF thermal-spray process. HVOF is one of the most commonly used thermal-spray processes because it can be used to deposit a wide variety of materials as dense, well-bonded coatings. In the HVOF process, powdered material is fed into a gun, where it is combined with oxygen and fuel. The process of coating the underside of a pump bowl is shown in Figure 19.

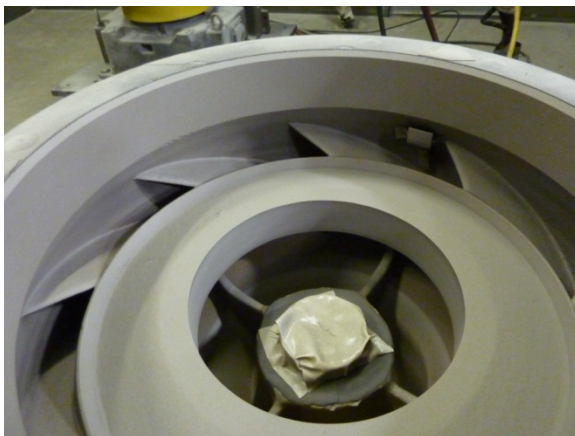
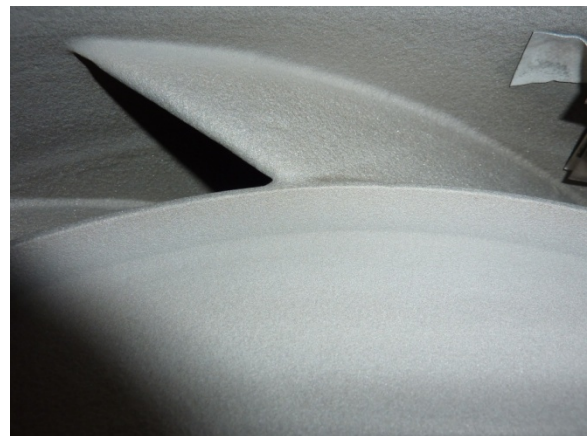
Figure 20. Condition of pump components after application of the Stellite 6 coating.

The specified thickness and adhesion of the Stellite 6 coating was confirmed with witness coupons, which are small plates made of the same material as the pumps that were coated alongside the pump components at

the time of processing. The appearance was found to be acceptable by the coater. The pristine condition of the coated pump components corresponds to an overall rating of 10 in accordance with ASTM B537 – Appearance; ASTM B537 – Protection; and ASTM D2809.

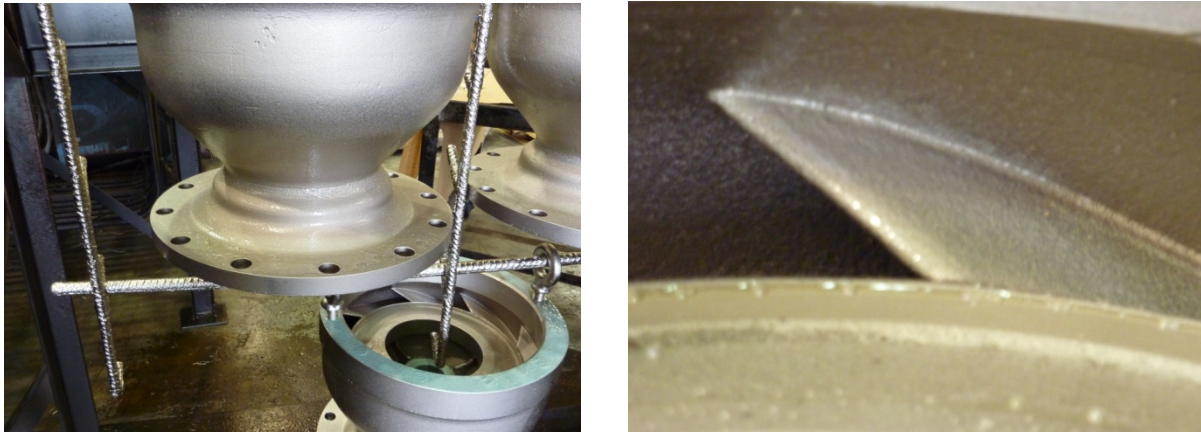
Figure 22. Condition of pump components after EN plating.

The pristine condition of the coated pump components corresponds to an overall rating of 10 in accordance with ASTM B537 – Appearance; ASTM B537 – Protection; and ASTM D2809. Coating thickness and adhesion were confirmed with witness coupons. The EN-coated parts were then heat treated for optimum wear and erosion resistance.
